Vegreville Flood Risk Mapping Study

Canada-Alberta Flood Damage Reduction Program

April 1994

SNC • LAVALIN

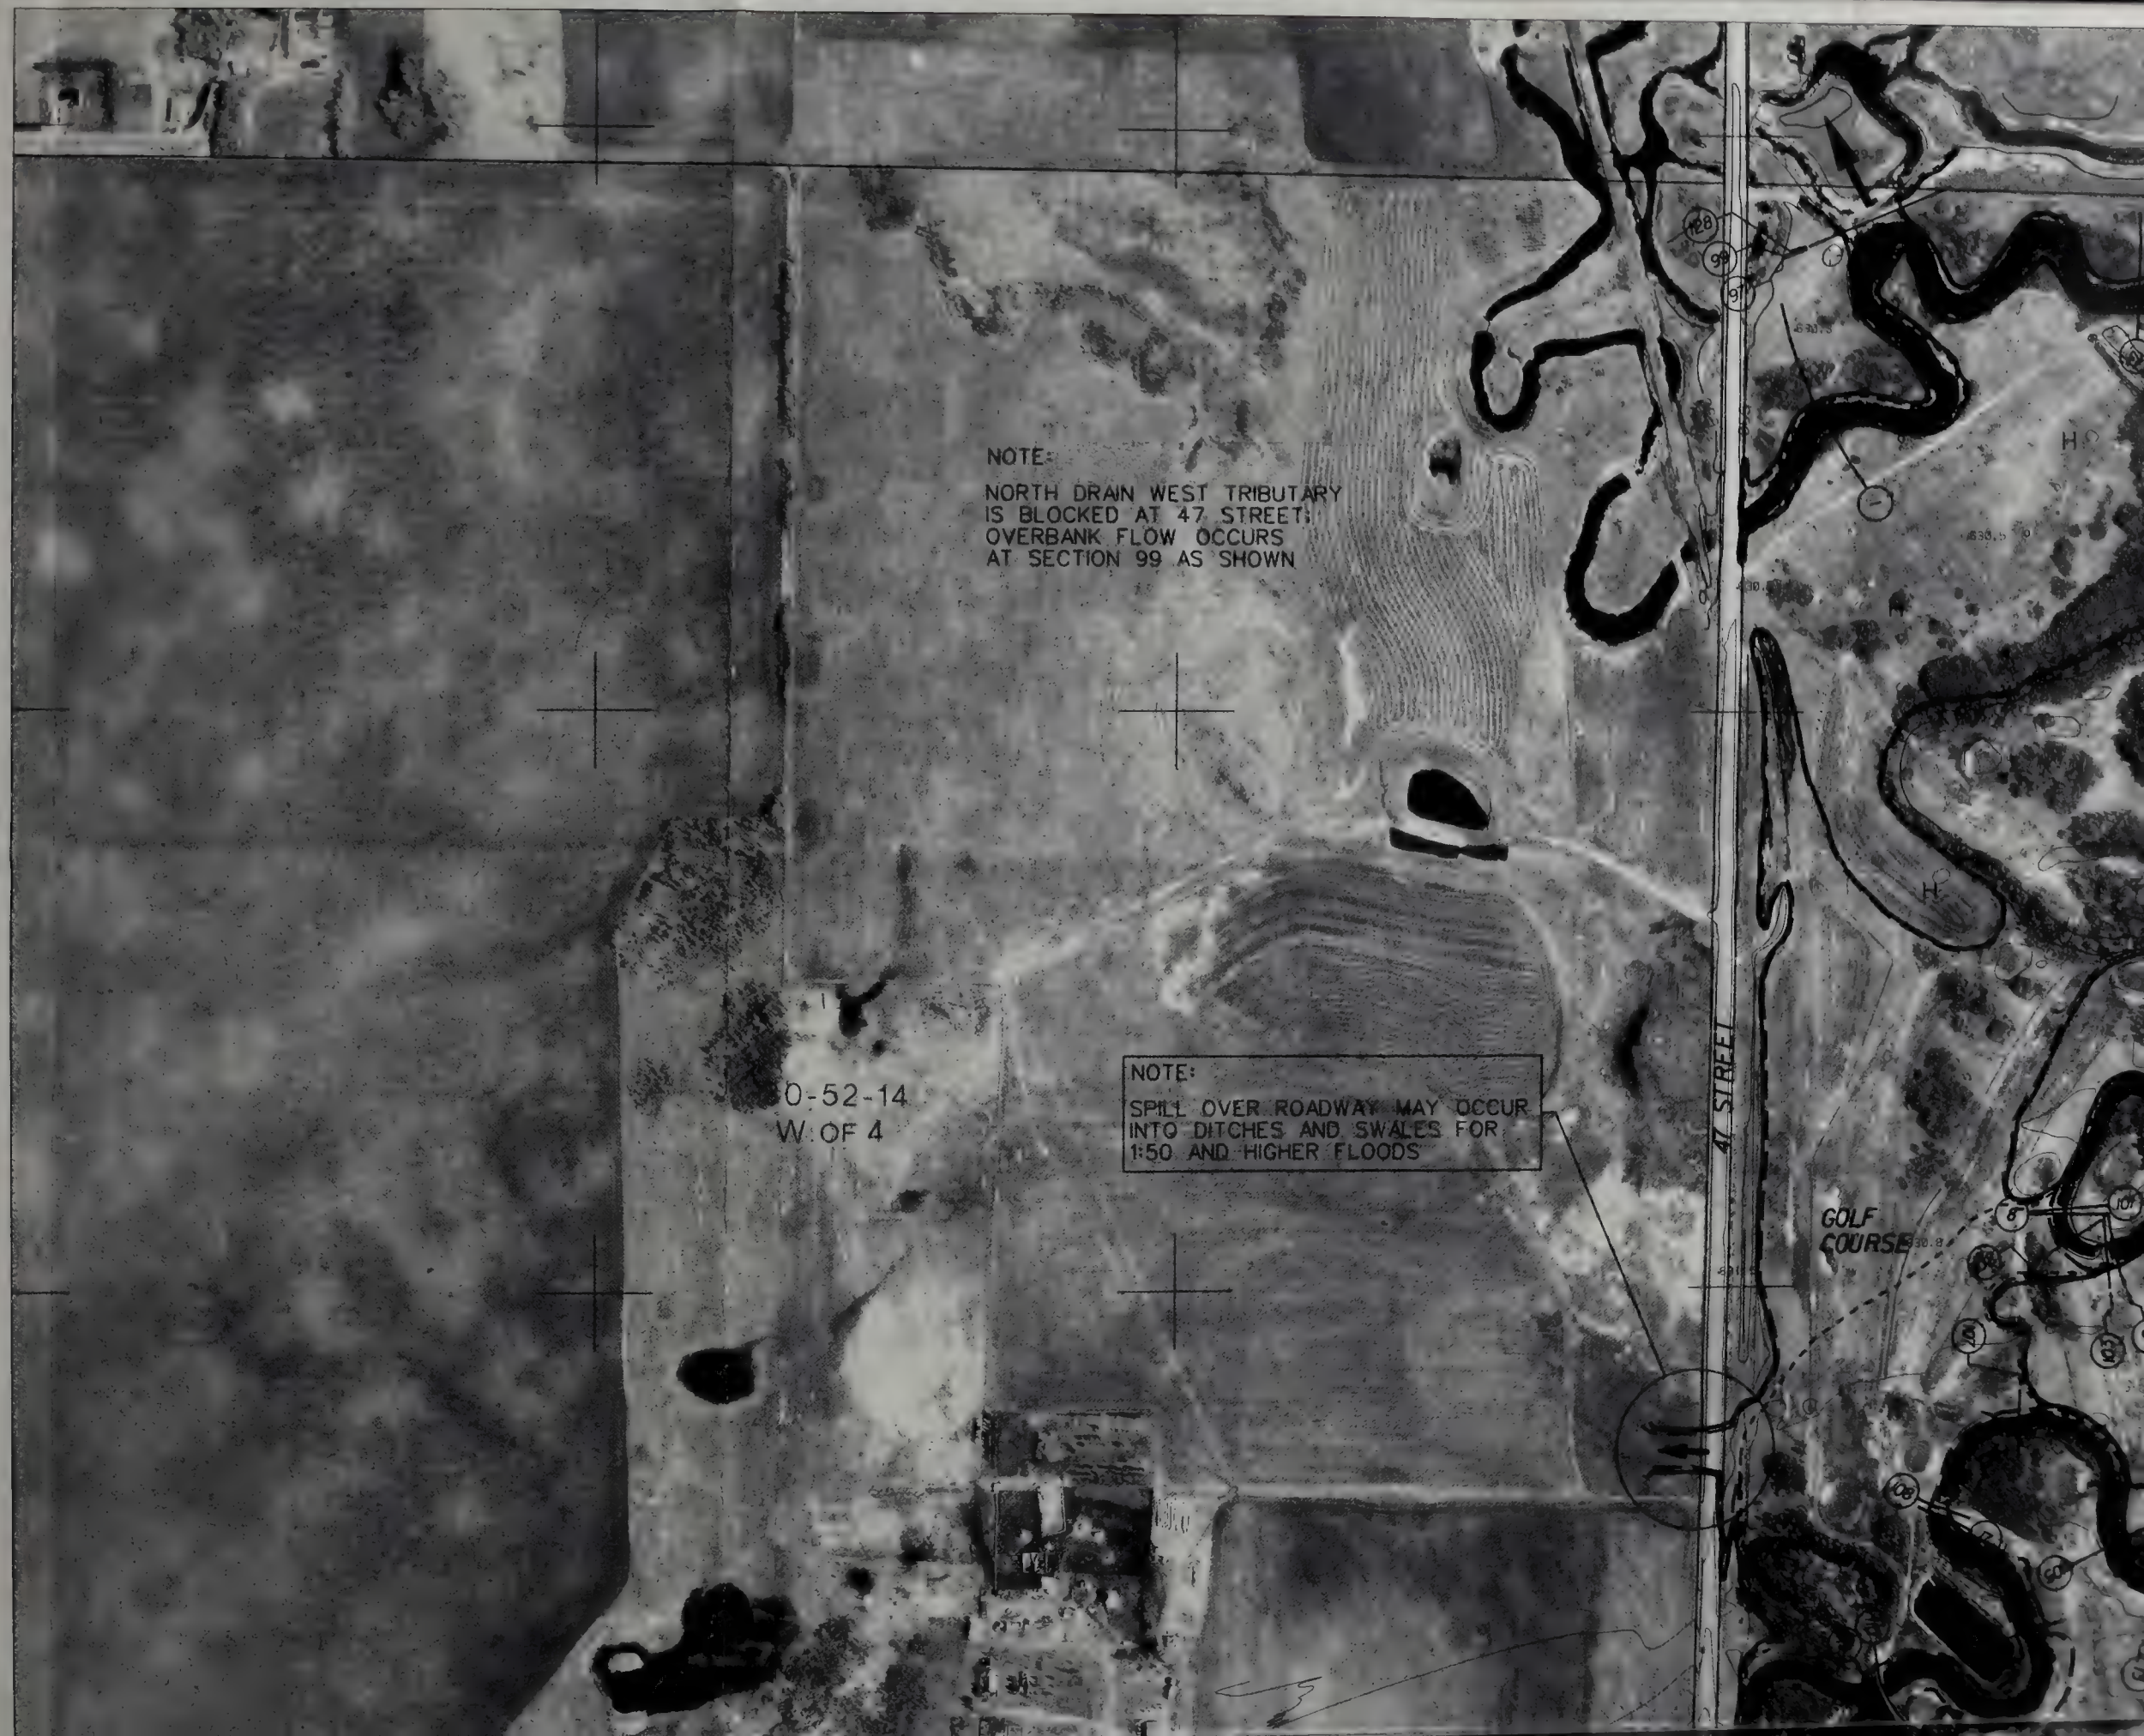
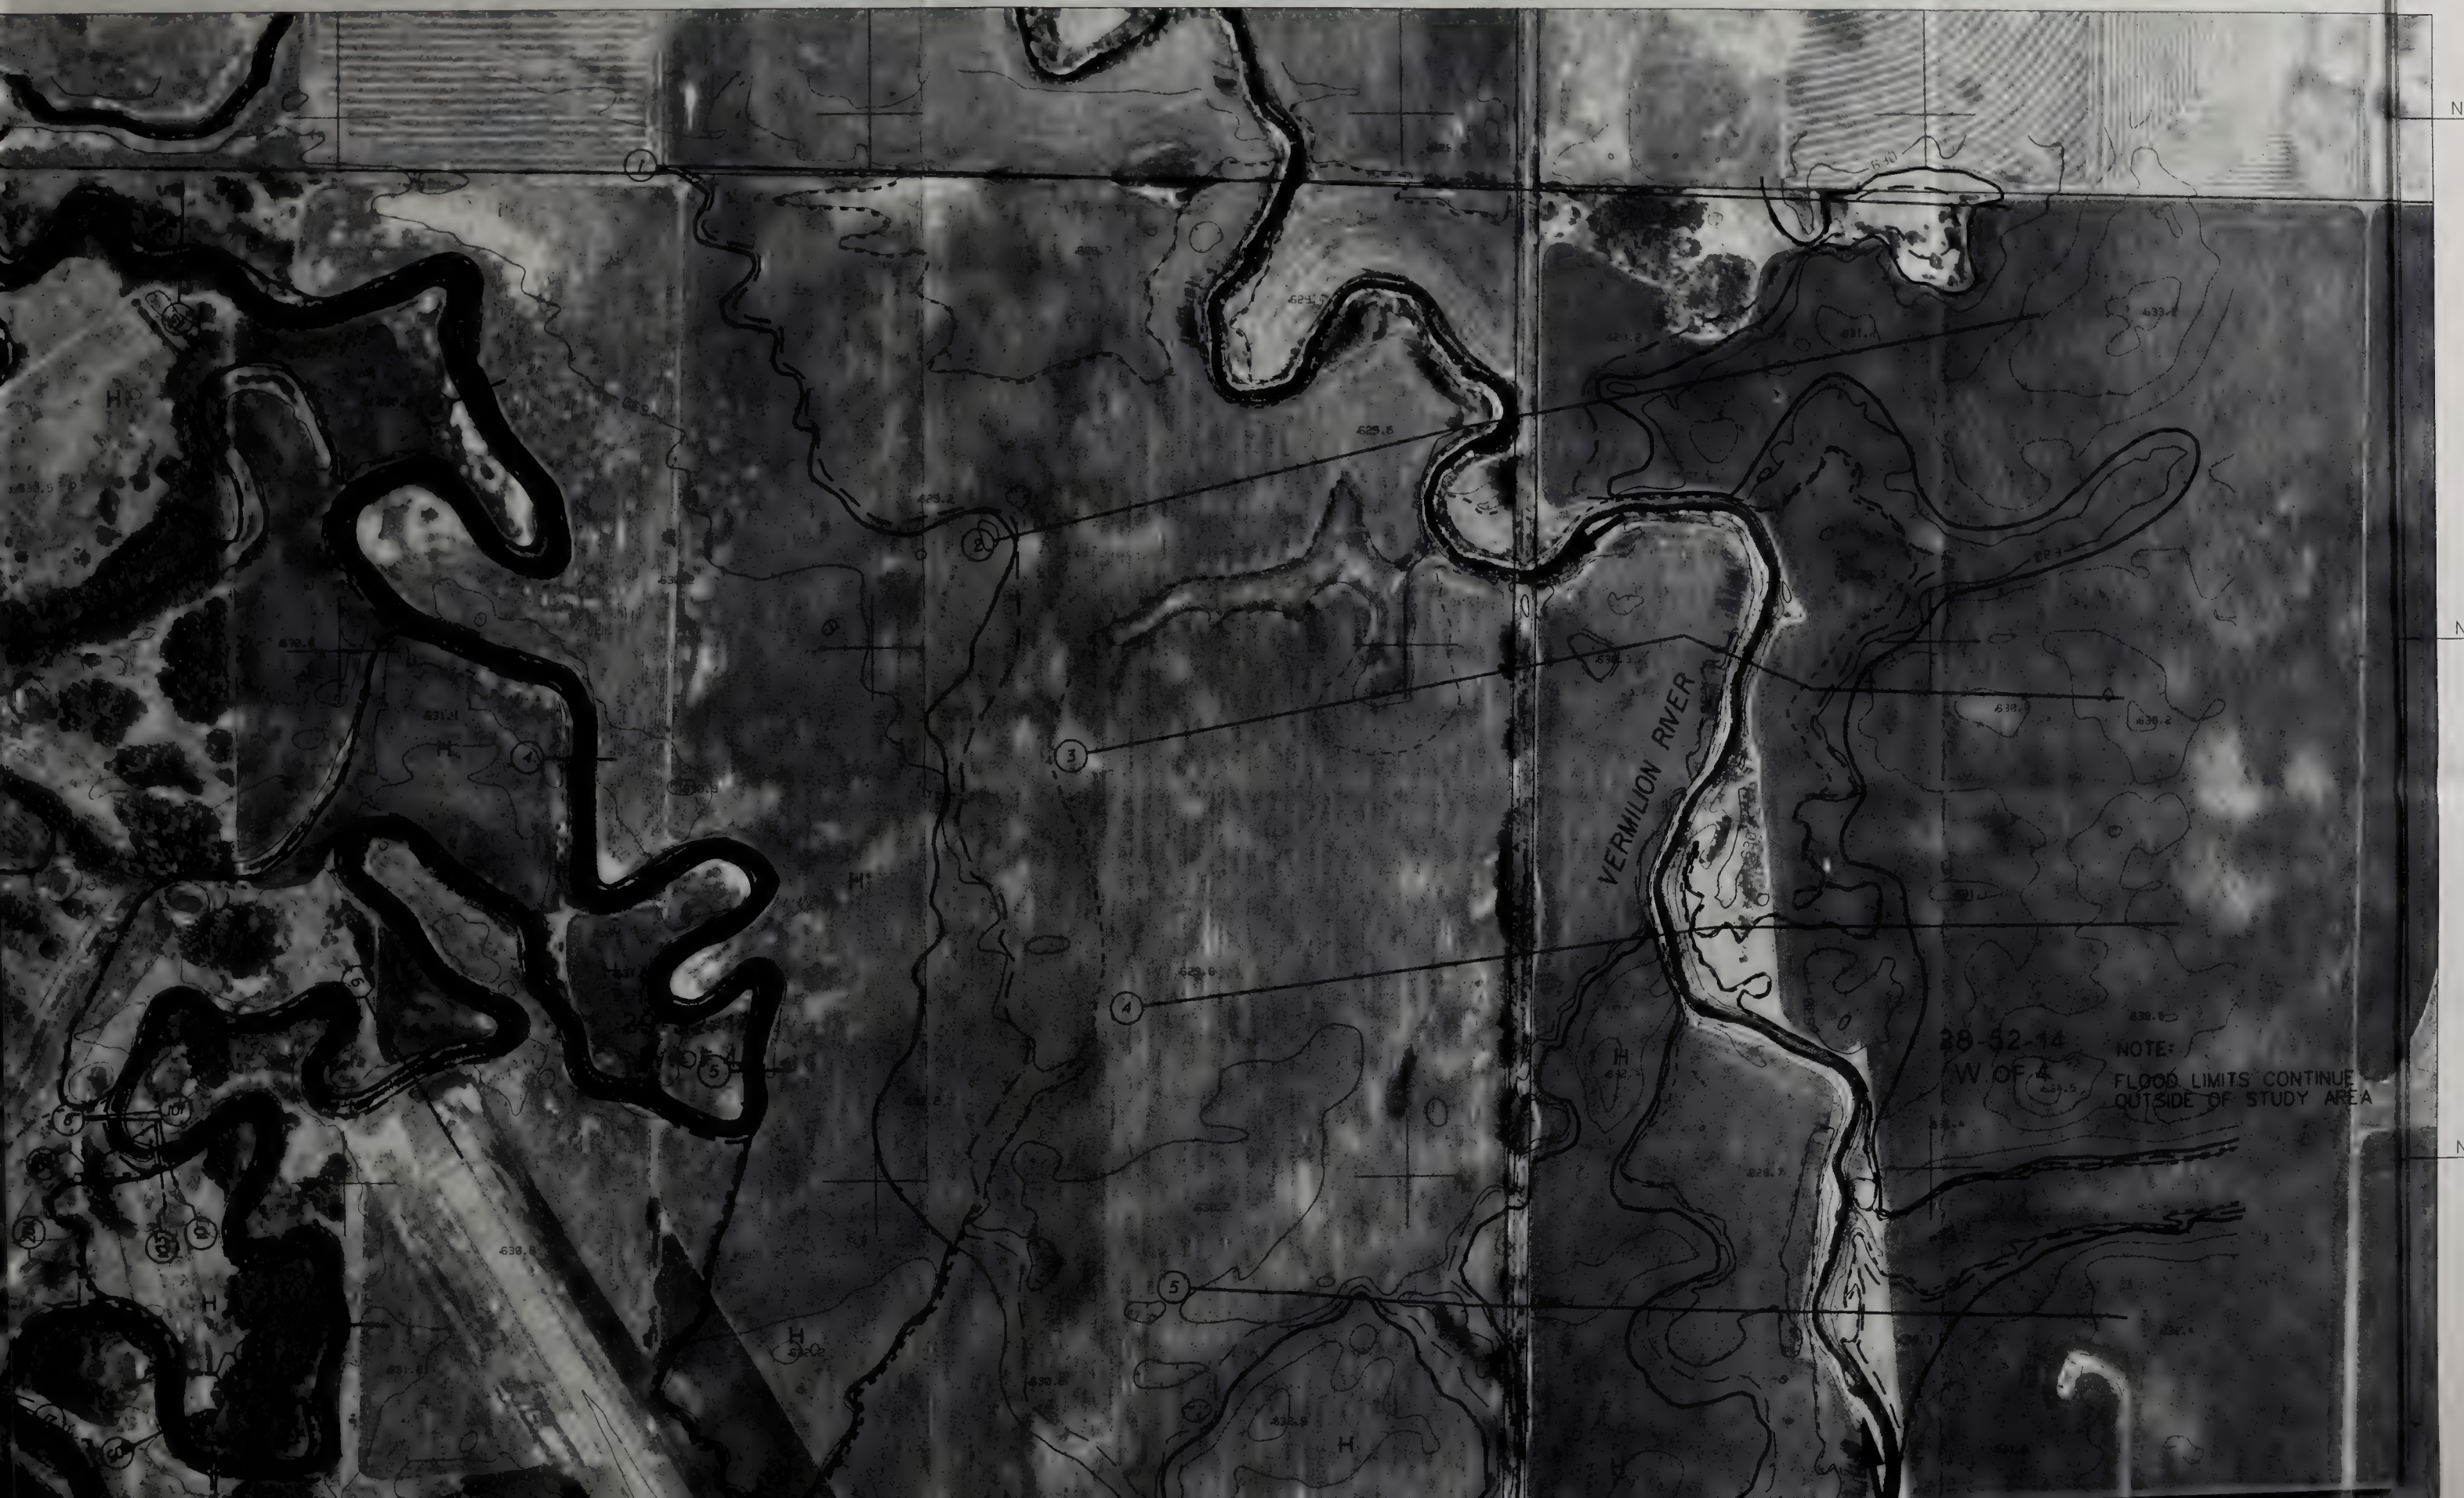
NOTE:
NORTH DRAIN WEST TRIBUTARY
IS BLOCKED AT 47 STREET;
OVERBANK FLOW OCCURS
AT SECTION 99 AS SHOWN

The NDWT contributes significantly to flooding in the airport area. That flooding is largely caused by small and blocked culverts through the golf course forcing flows to overtop the crossings. Reconstruction of these crossings to provide a lower overflow elevation would reduce inundation significantly.

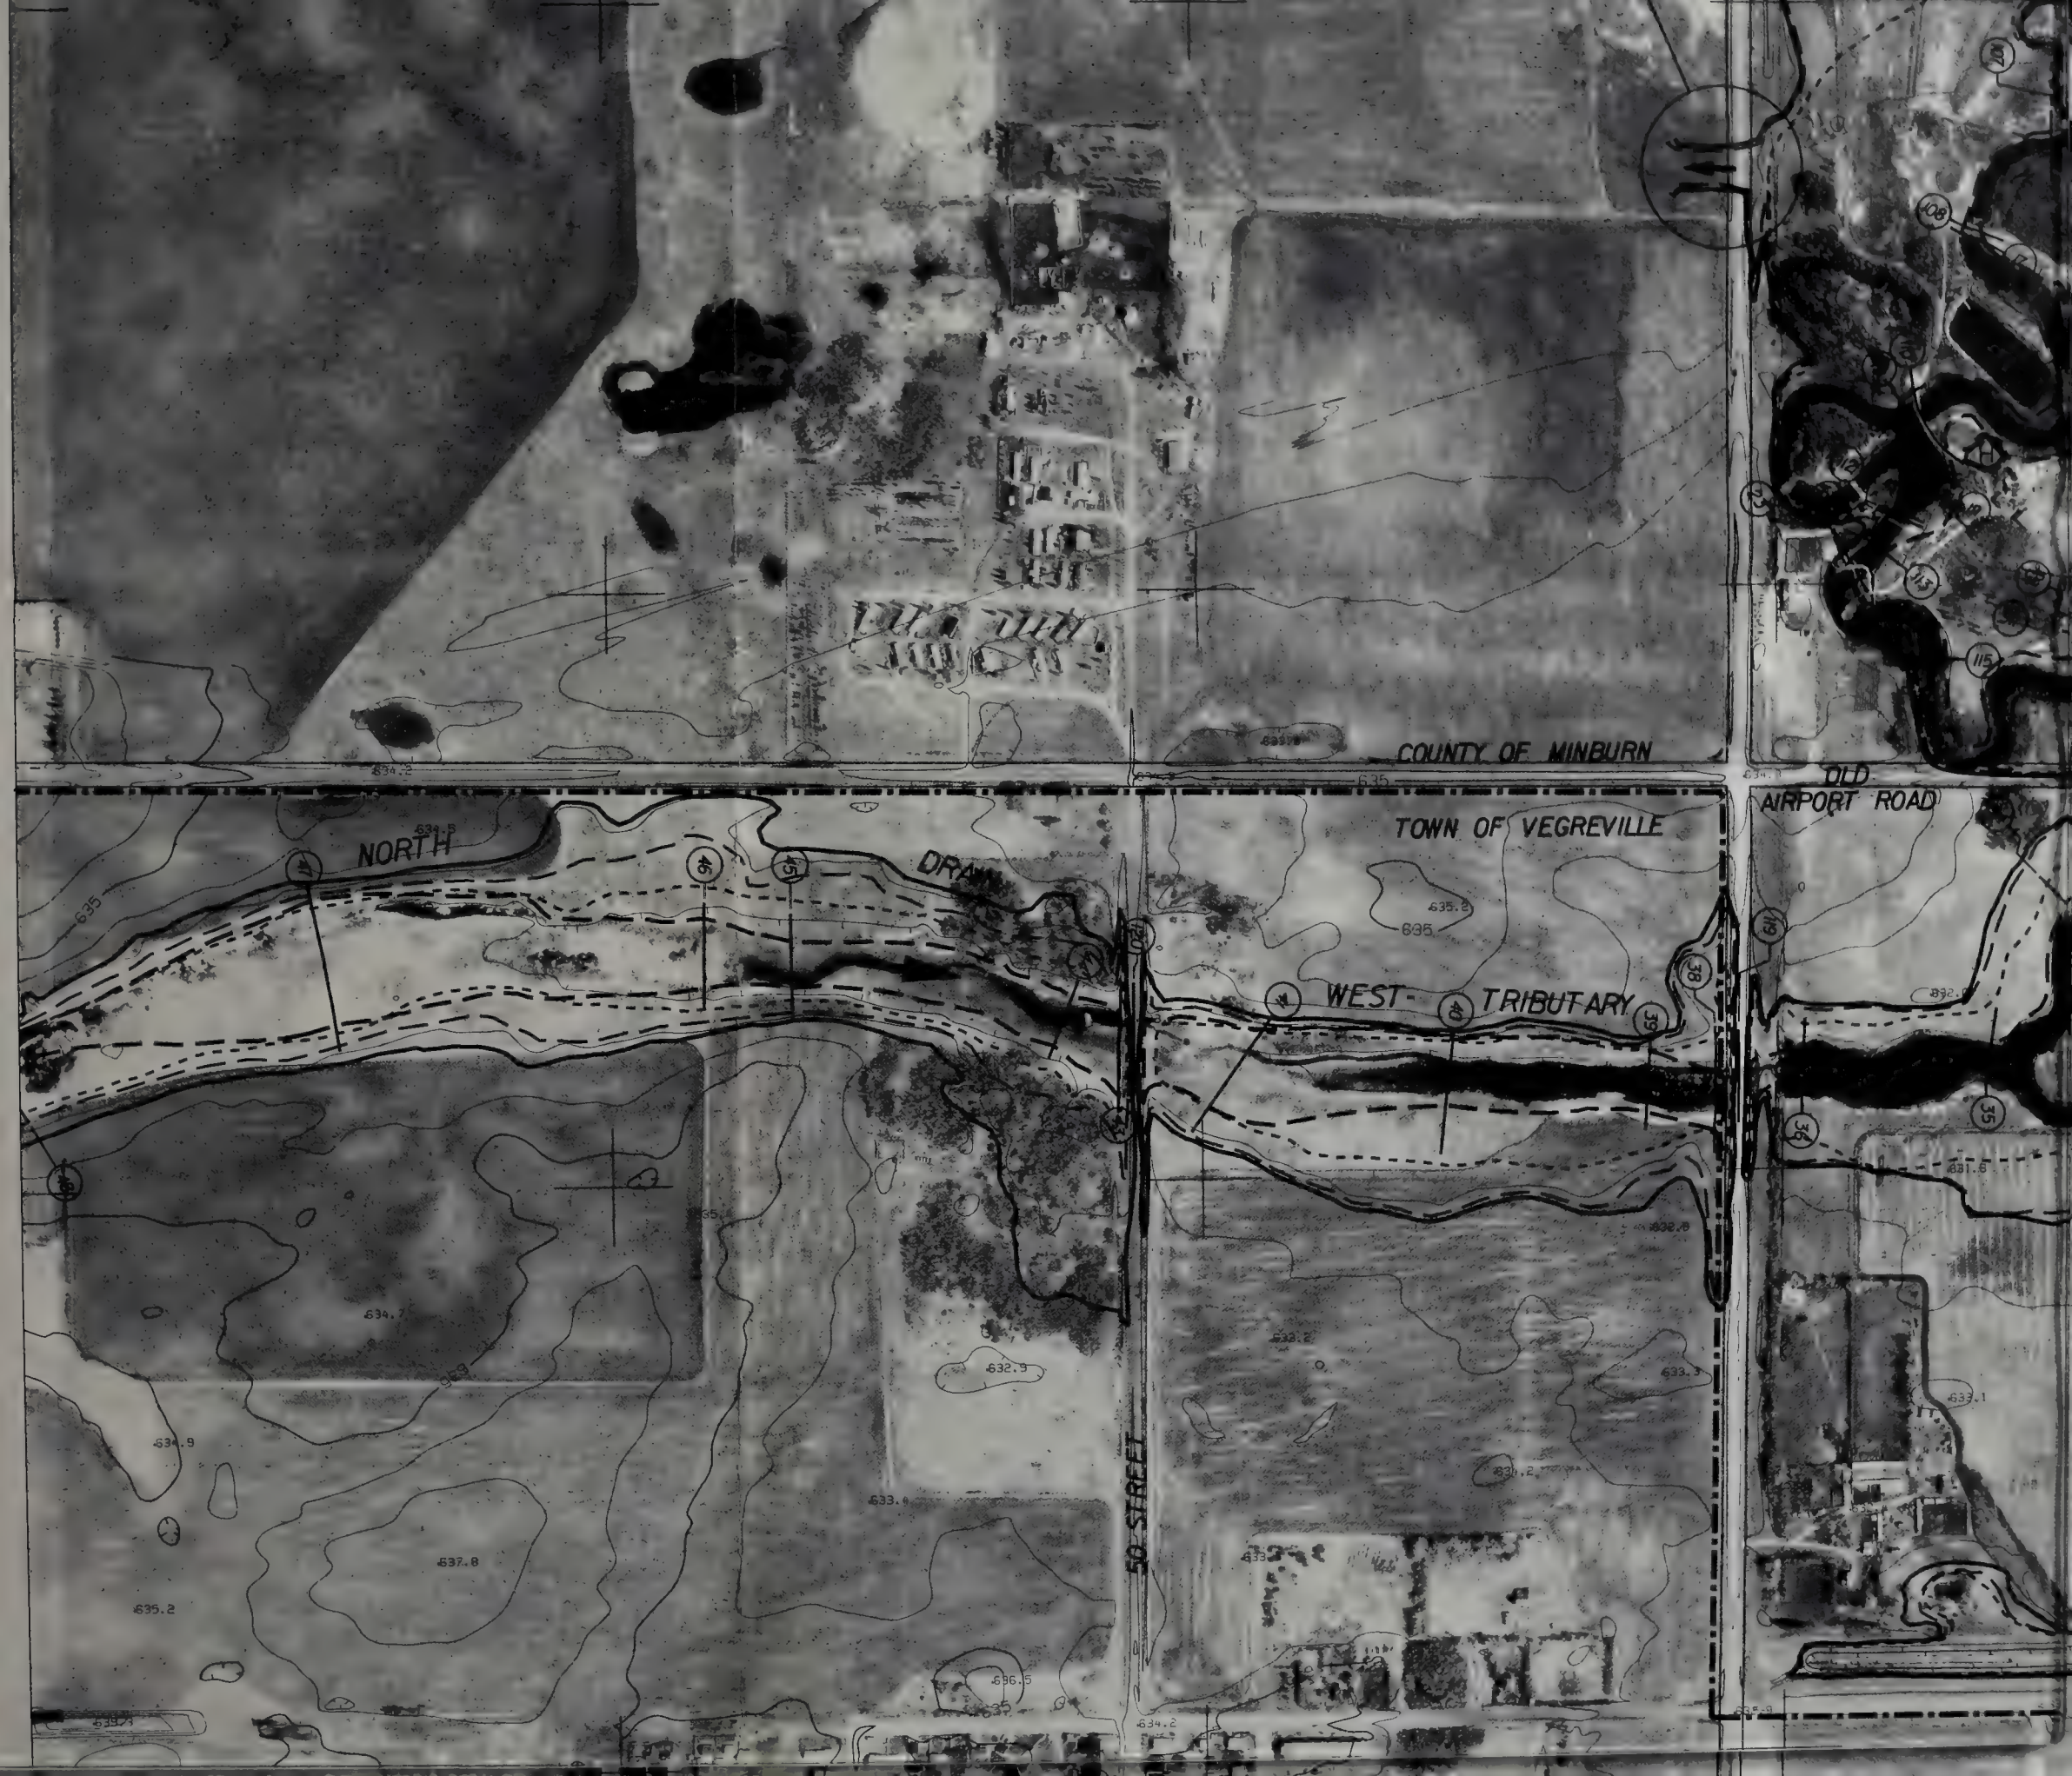
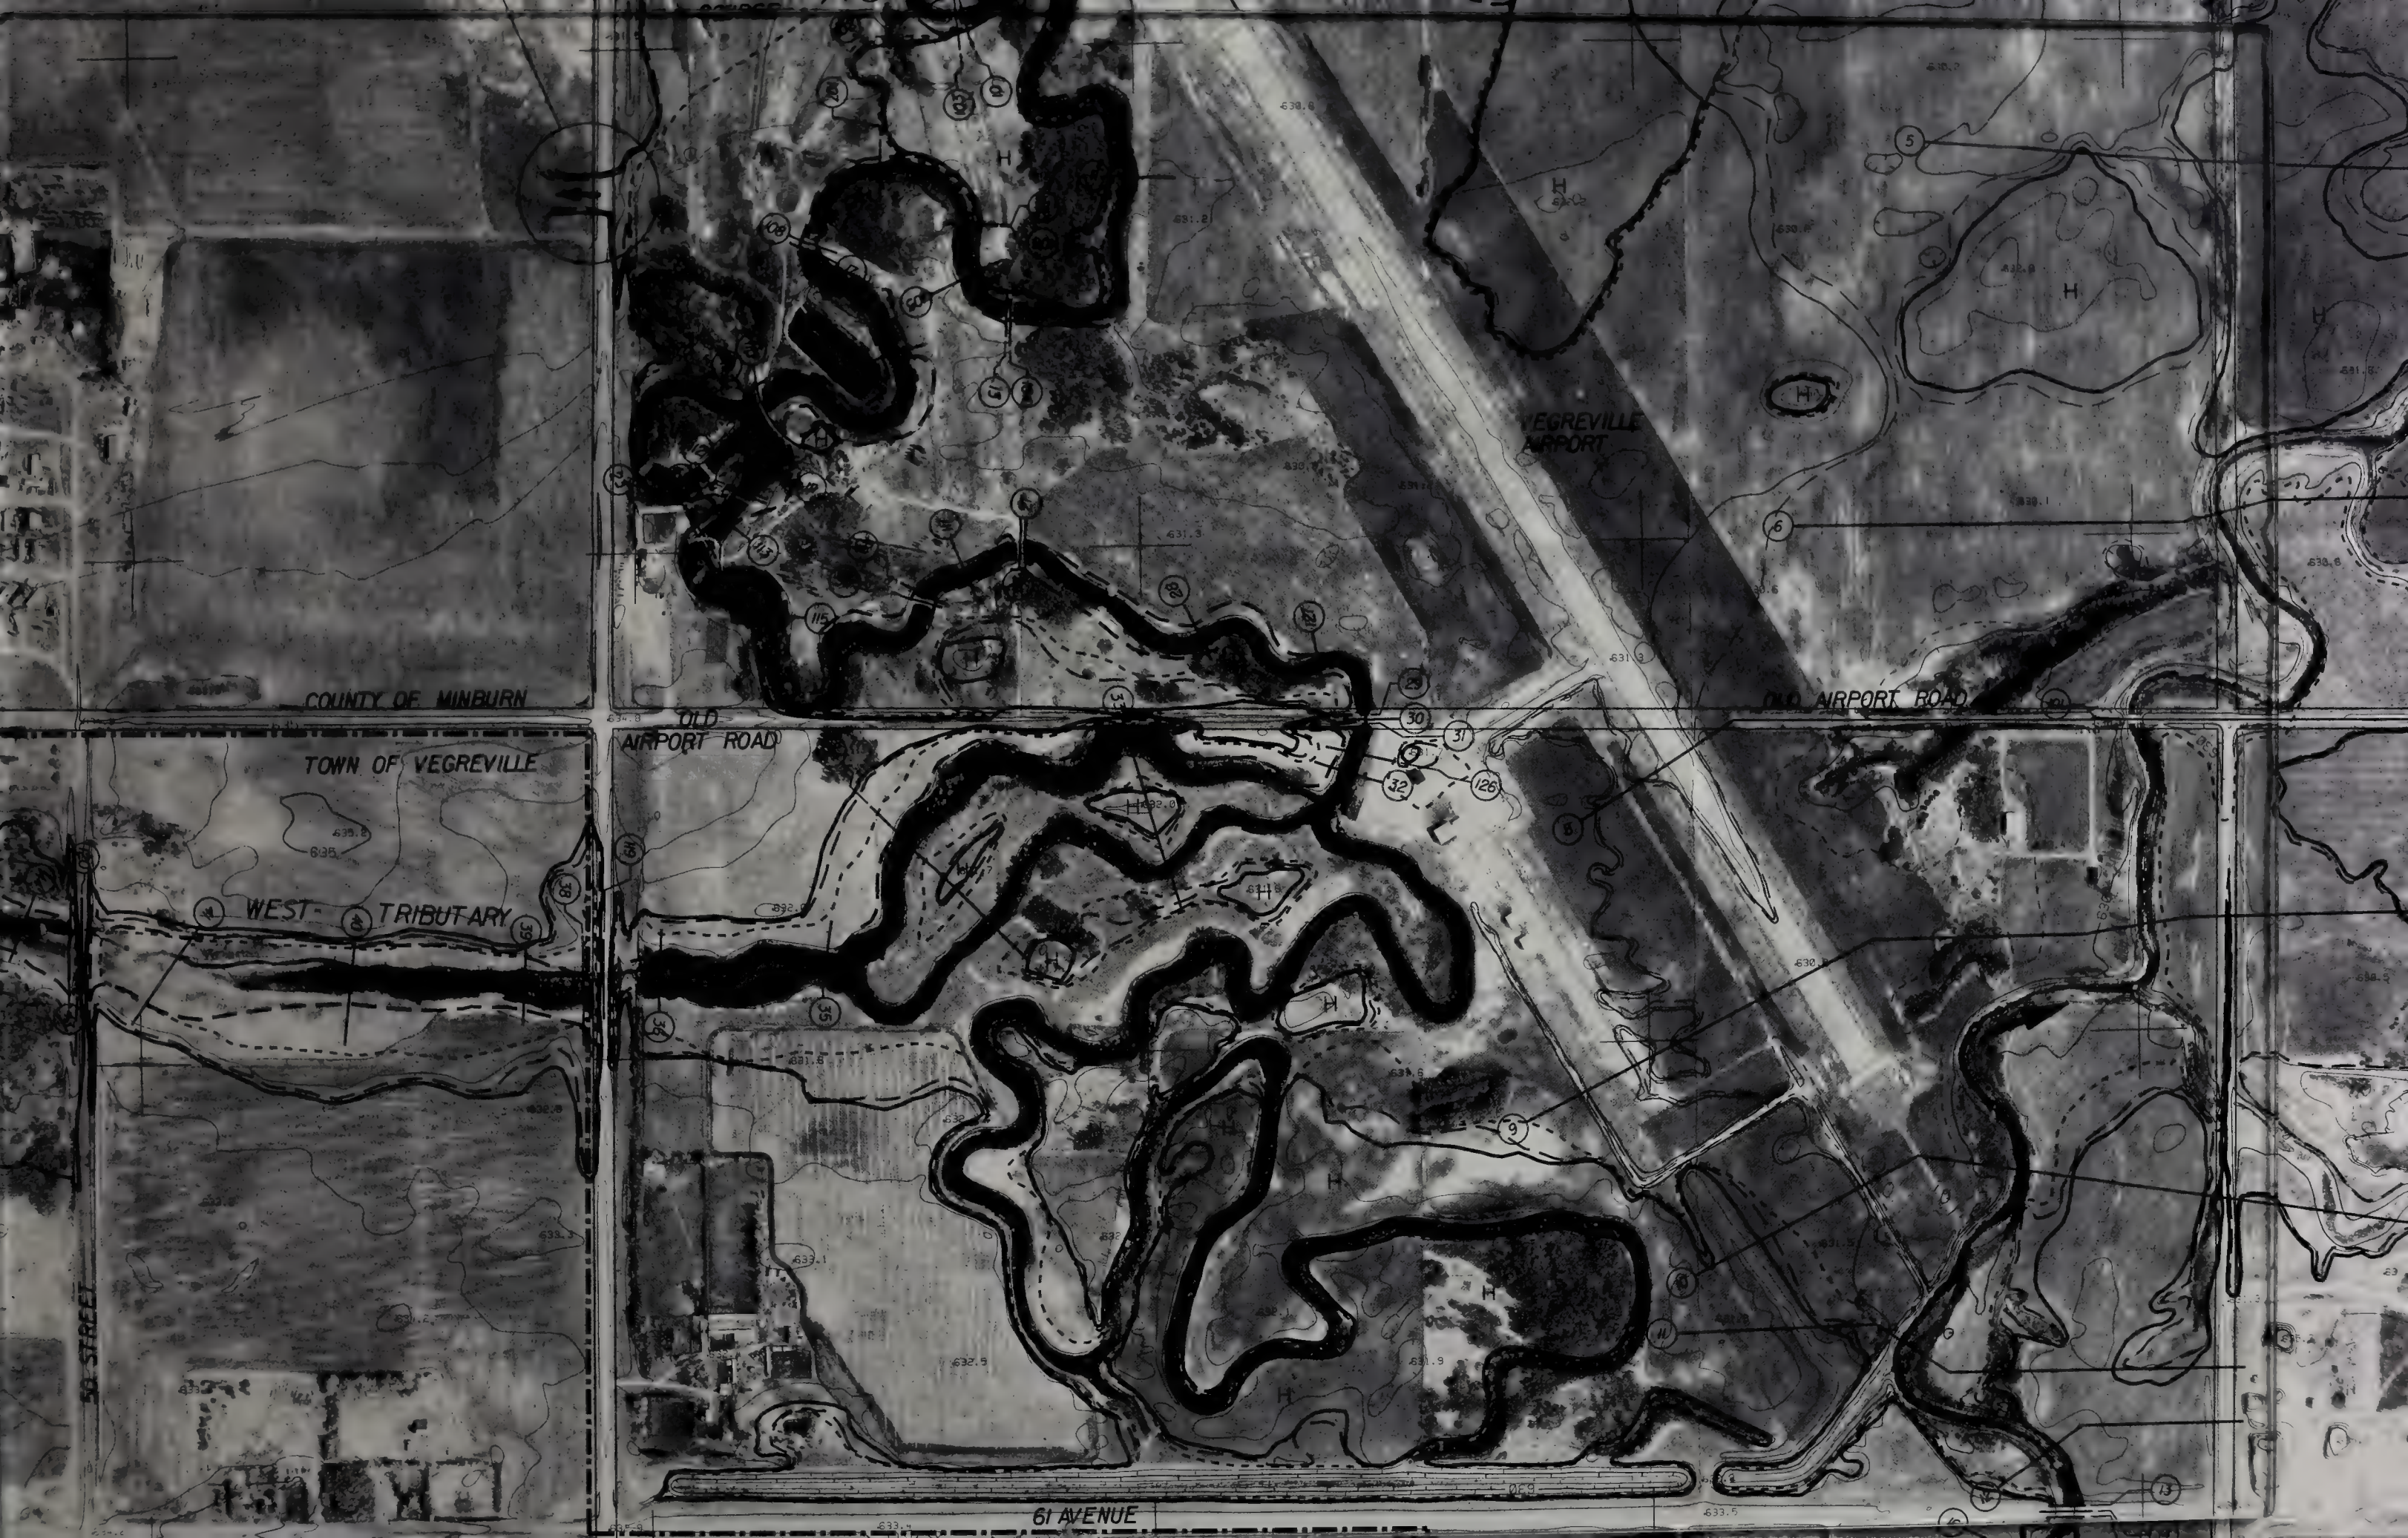
IN THE VEGREVILLE AIRPORT AREA OVERBANK FLOODING FROM THE NORTH DRAIN WEST TRIBUTARY (NDWT), WILL TEND TO BE AT A HIGHER ELEVATION THAN OVERBANK FLOODING FROM THE VERMILION RIVER. THIS WILL TEND TO CAUSE FLOOD WATERS TO FLOW FROM THE NDWT TO THE VERMILION RIVER. IN THAT SITUATION THE VERMILION RIVER LEFT OVERBANK FLOOD LIMITS WILL BE SUPERSEDED BY THE FLOW COMING FROM THE NDWT. NEVERTHELESS THE VERMILION RIVER LEFT OVERBANK FLOOD LIMITS HAVE BEEN RETAINED ON THIS MAP, BUT AS LIGHTER LINES.
